TURNER LAKE DAM
DENT COUNTY, MISSOURI

MISSOURI INVENTORY NO. 30266

PHASE I INSPECTION REPORT
NATIONAL DAM SAFETY PROGRAM

SEPTEMBER 1978

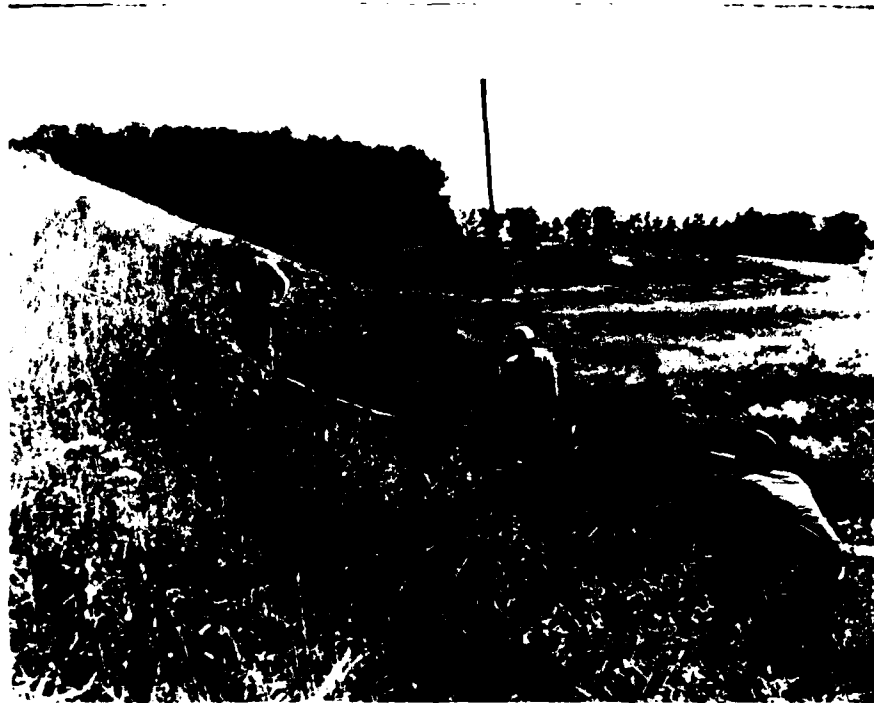
PHOTO 3 Downstream Slope of Dam Toward
 Left Abutment

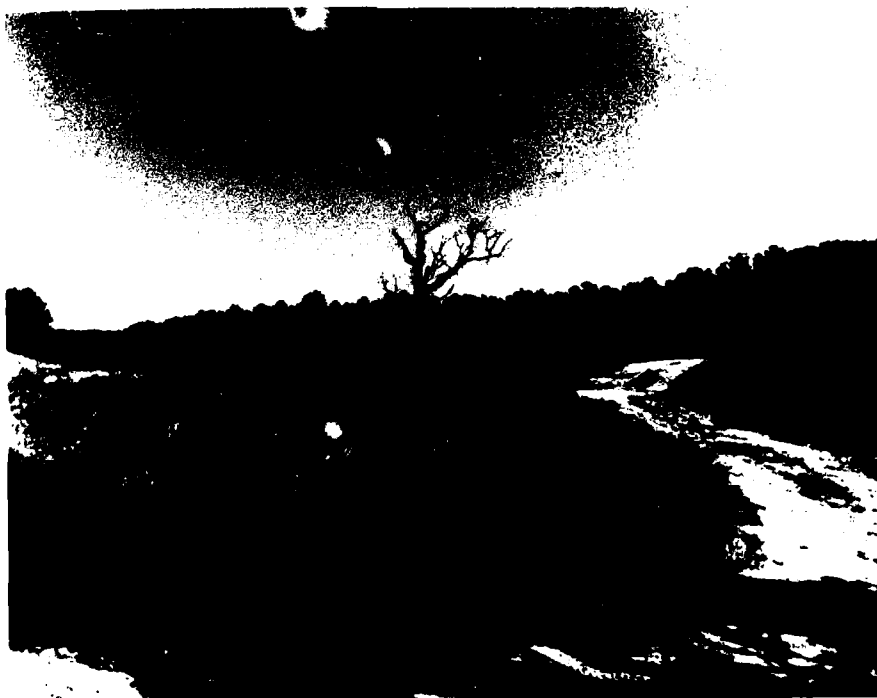
(4) A grassy spillway located at the right side of the dam serves as an emergency spillway (See Plates 2 and 3 and Photos 6 and 7). Any high and sustained flows through the emergency spillway could cause excessive erosions of the embankment. The excessive erosions could threaten the safety of the dam.

PHOTO 6 Spillway

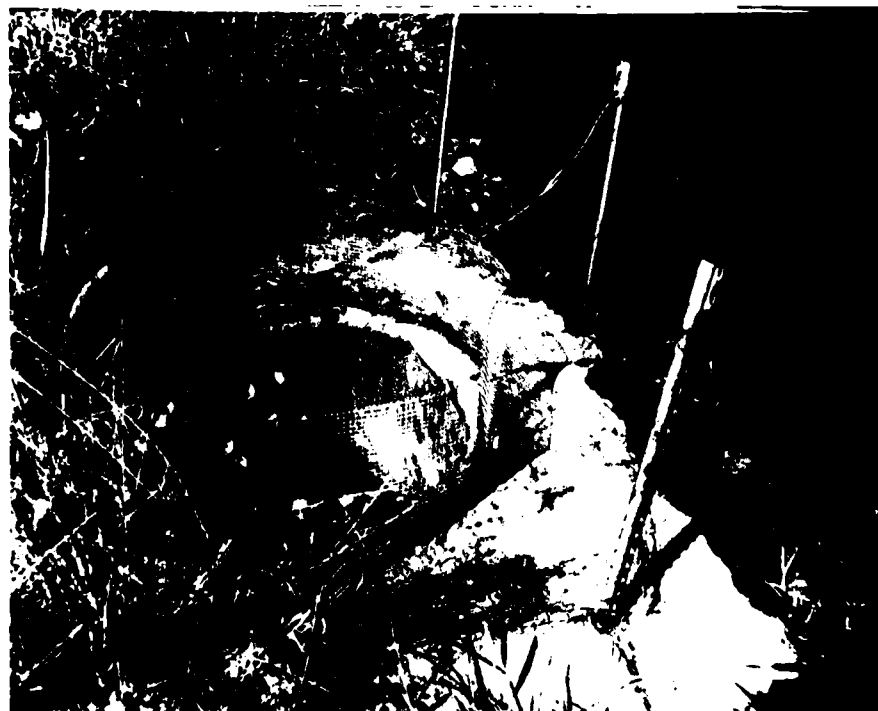
PHOTO 8 Overflow Intake
